11 September 2023  
PE\_2023\_20-L01

**Subject: Environmental Auditor verification of the implementation of the Site Management Plan – 21 Northumberland and 26 Wellington Streets, Collingwood, Victoria**

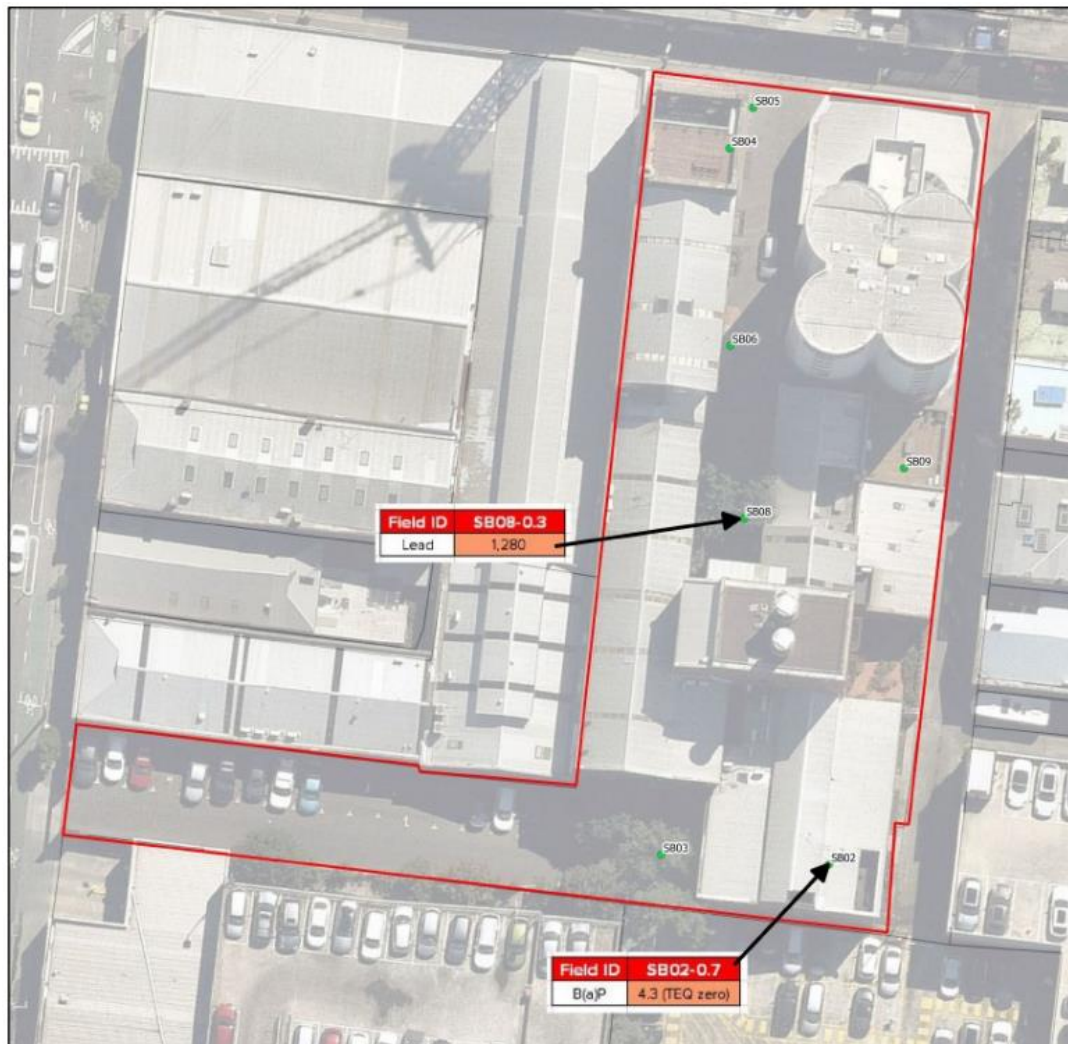
**Figure A: Soil Assessment Criteria Exceedances**

The Site Management Plan (SMP) was prepared to manage and reduce the potential risk to site occupants (including residents and workers), and any maintenance workers who may conduct excavation works at the site, due to elevated concentrations of contaminants in soils (lead and benzo(a)pyrene) in isolated areas of the site. An extract from the SMP of the soil contamination identified at the site is shown on **Figure A** below.

The lead contamination identified in the central courtyard area as shown on **Figure A** above, has now been remediated. Some contamination still remains at the site (i.e., benzo(a)pyrene (B(a)P) located in the carpark area in the south-eastern part of the site), and it is possible that additional contaminated fill is present in other sealed areas of the site.

The remediation works removed the lead contaminated soils to a depth of approximately 0.5 m below the surrounding pavement level in the garden beds, and replaced the soil with imported clean fill from a garden supplies retailer. The contaminated soils and 'hydro mud' which were excavated during the remediation works were disposed of appropriately to EPA Licensed facilities, as demonstrated by the waste disposal documentation included in Appendix B of the attached Helia Report.

The Auditor recommends that the entity in control of the site (VDSOC) can meet its Duty to Manage residual contaminated soil at the site by continuing to implement the Site Management Plan (SMP) where sub-surface maintenance works are required at the site. That is, if in future any soil is required to be excavated at the site, VDSOC should implement the requirements of the SMP, such as making any construction workers aware of the potential for the presence of soil contamination, and appropriately testing and disposing of any soils which are to be removed from the site. This does not apply to the areas of the garden beds in the central courtyard area where remediation works have been completed for the uppermost 0.5 m depth of soils.
