# **Victorian Distillery and Silos Owners Consortium**

Site Management Plan – SMP

21 Northumberland and 26 Wellington Streets,  
Collingwood, Victoria 3066

| <b>Document Title</b> | Site Management Plan – SMP |

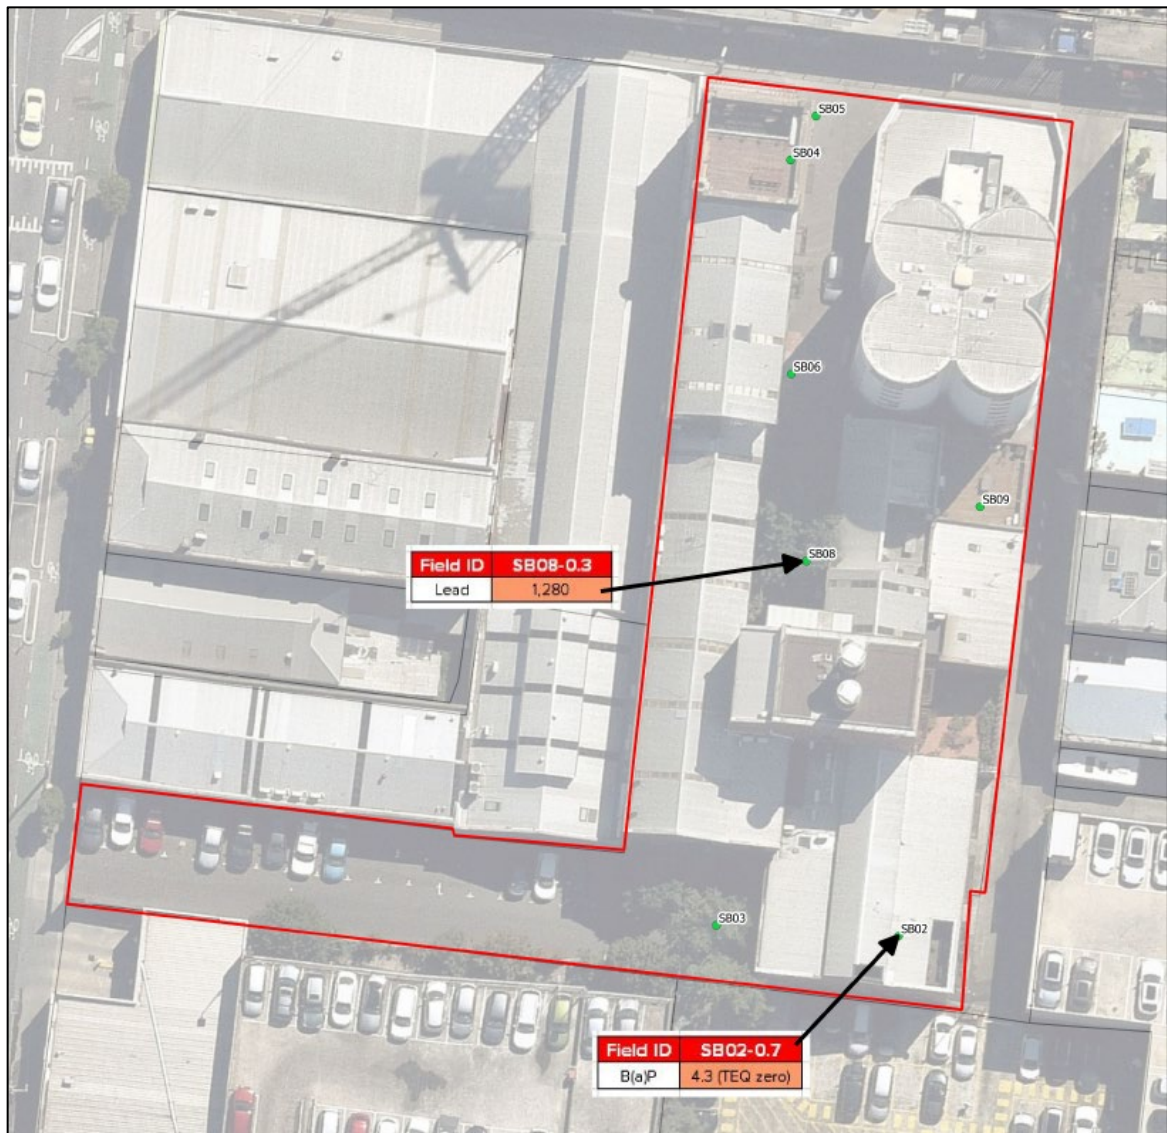
**Figure A: Soil Assessment Criteria Exceedances**

**Figure A** and **Table 2** provide a brief summary of where residual contamination is present at the Site, based on all data available.

| Media | Exceeds criteria | Analytes | Location | Year / reference |
|---|---|---|---|---|
| Soil | ✓ | Lead and benzo(a)pyrene | SB08 and SB02 | 2018, <b>20170561-R-03</b> |

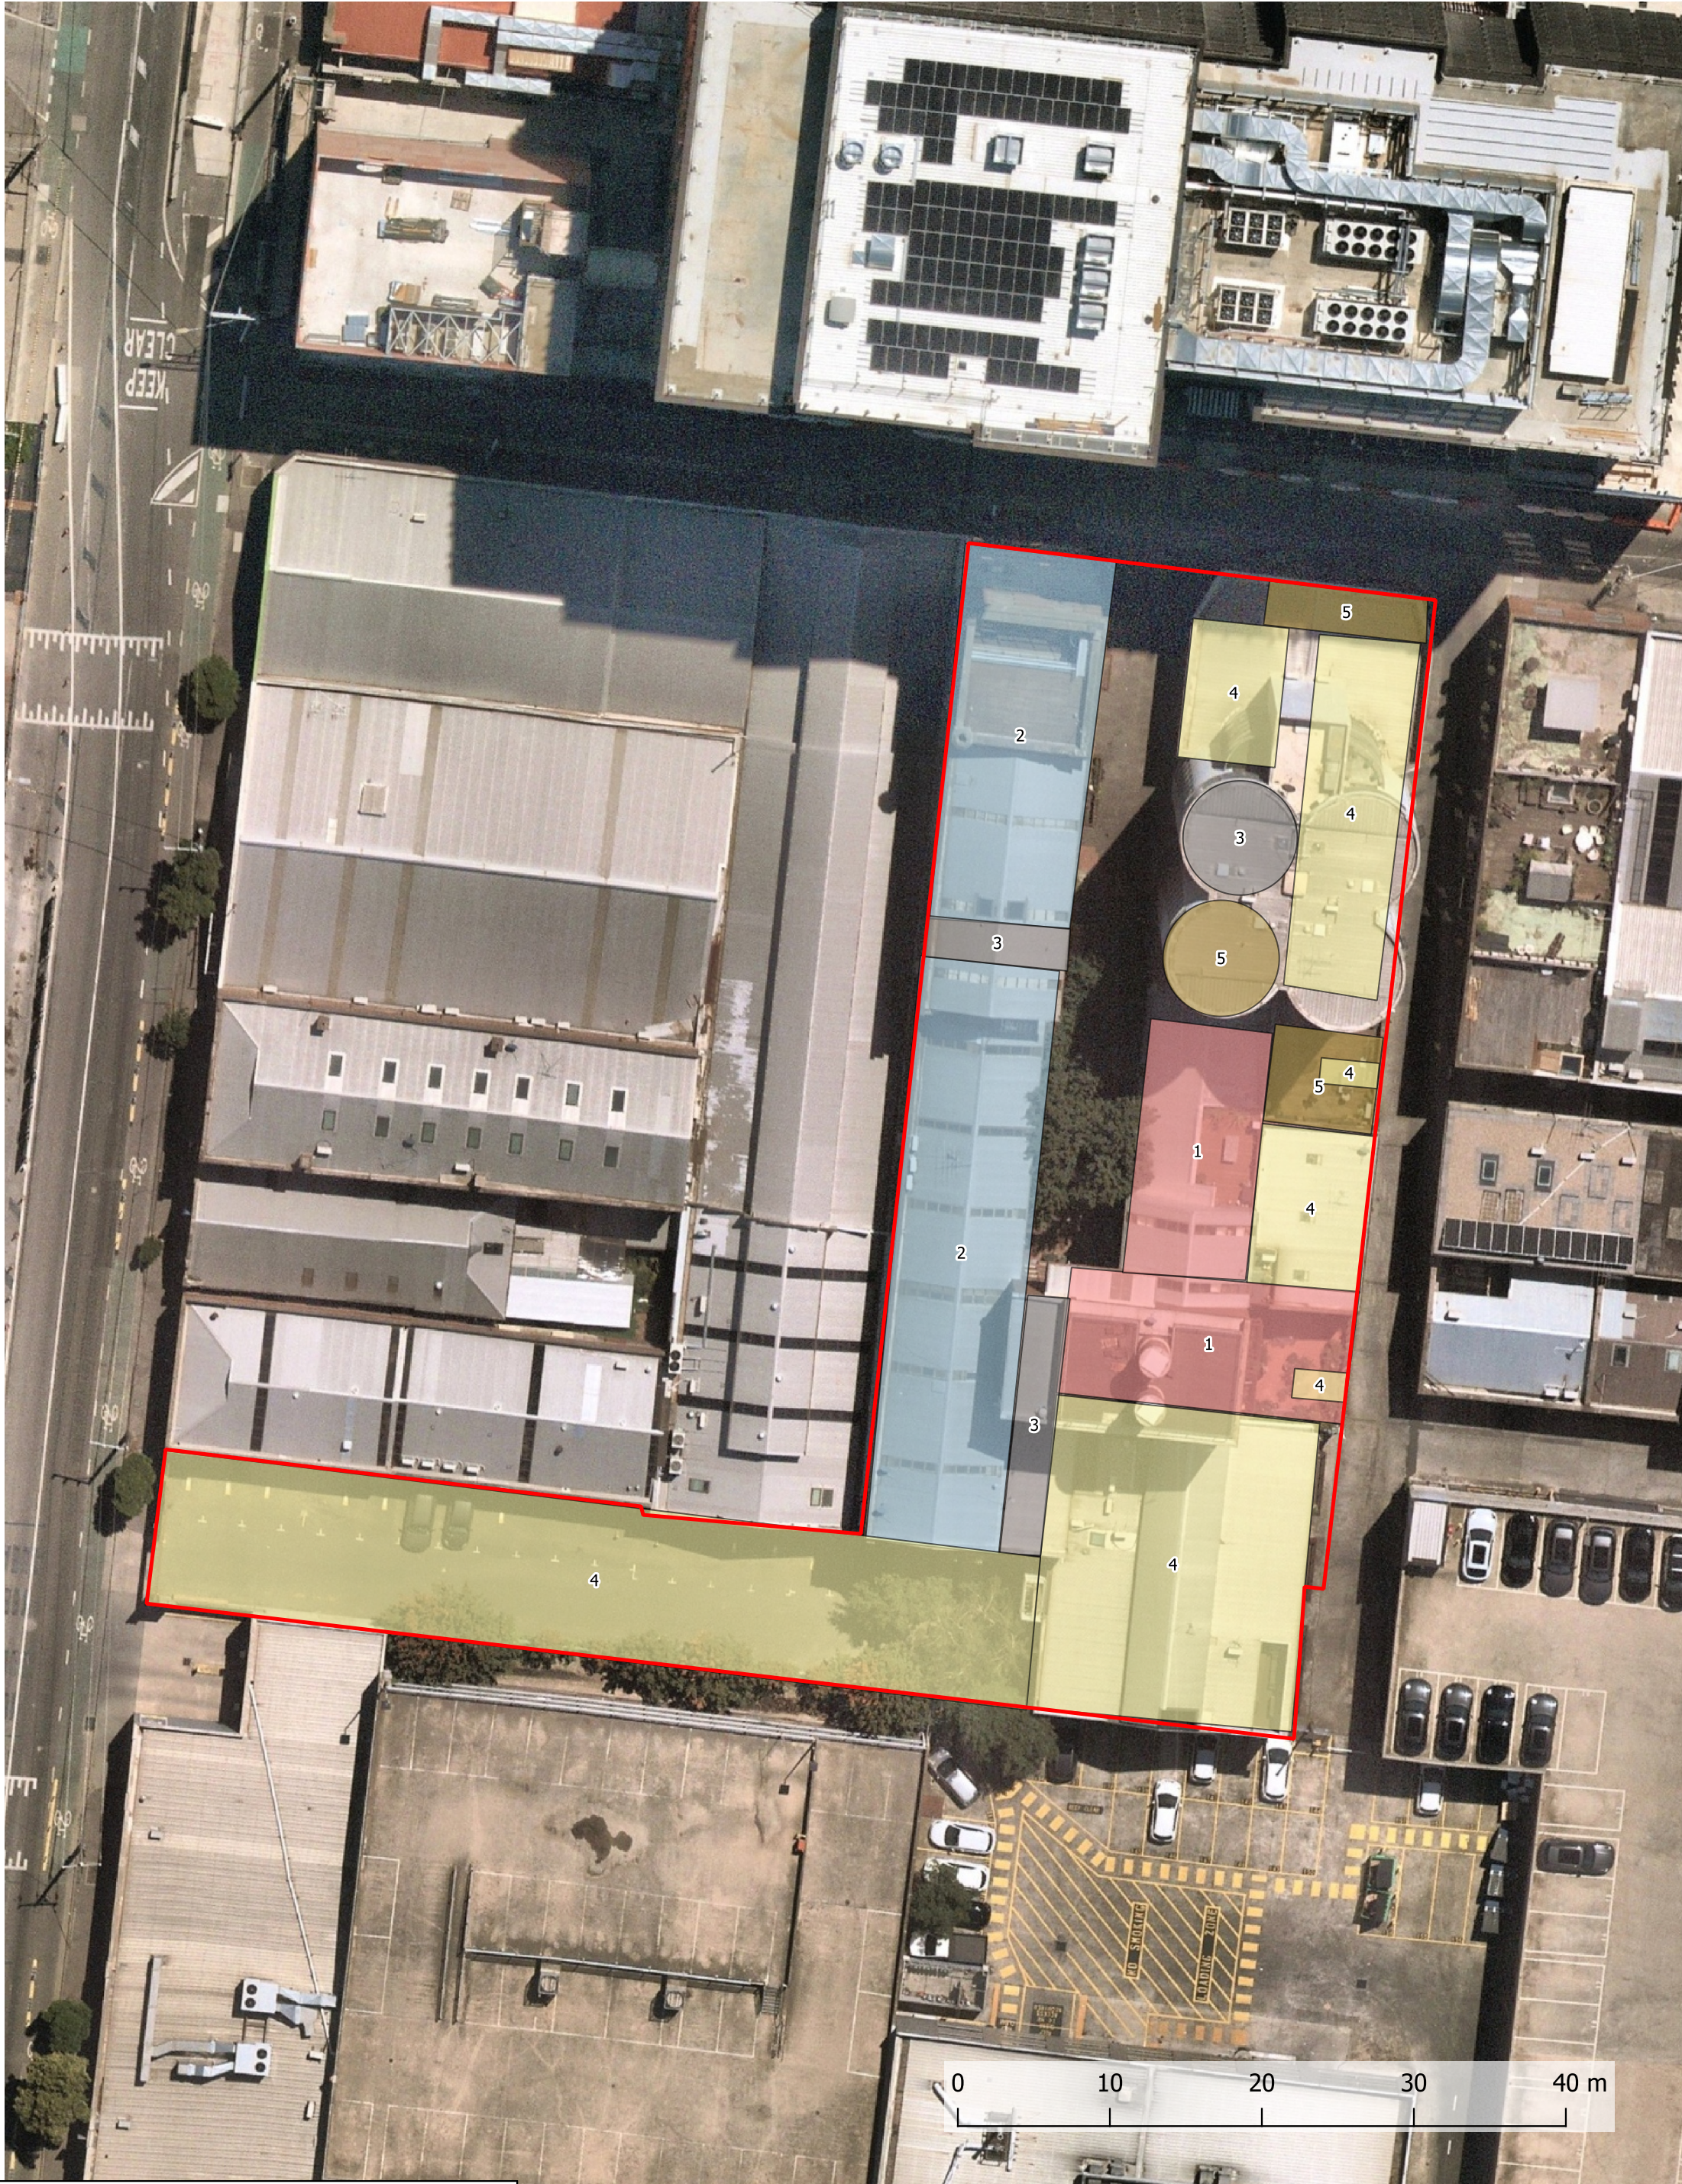
| A3 | Drawn: ND | Date: 24/02/2021 | Figure 1 |

Site Layout  
Victorian Distillery and Silos Owners Consortium  
21 Northumberland & 26 Wellington Streets, Collingwood, Vic

Edge Group Pty Ltd (Edge) was engaged by Victorian Distillery and Silos Owners Consortium (VDSOC) (the Client) to prepare a Site Management Plan (SMP) for the site located at 21 Northumberland and 26 Wellington Streets, Collingwood (the Site). The Site comprises multiple lots (approximately 2,875 m<sup>2</sup> combined total area), which were redeveloped for partial commercial and partial residential land uses. A large portion of the ground floor is used for car parking. Refer to **Figure 1** for the Site Layout.
